MILANO LINATE AIR ACCIDENT, 20TH ANNIVERSARY

By Veronica Taliano, Peer Support Programme & HF Coordinator

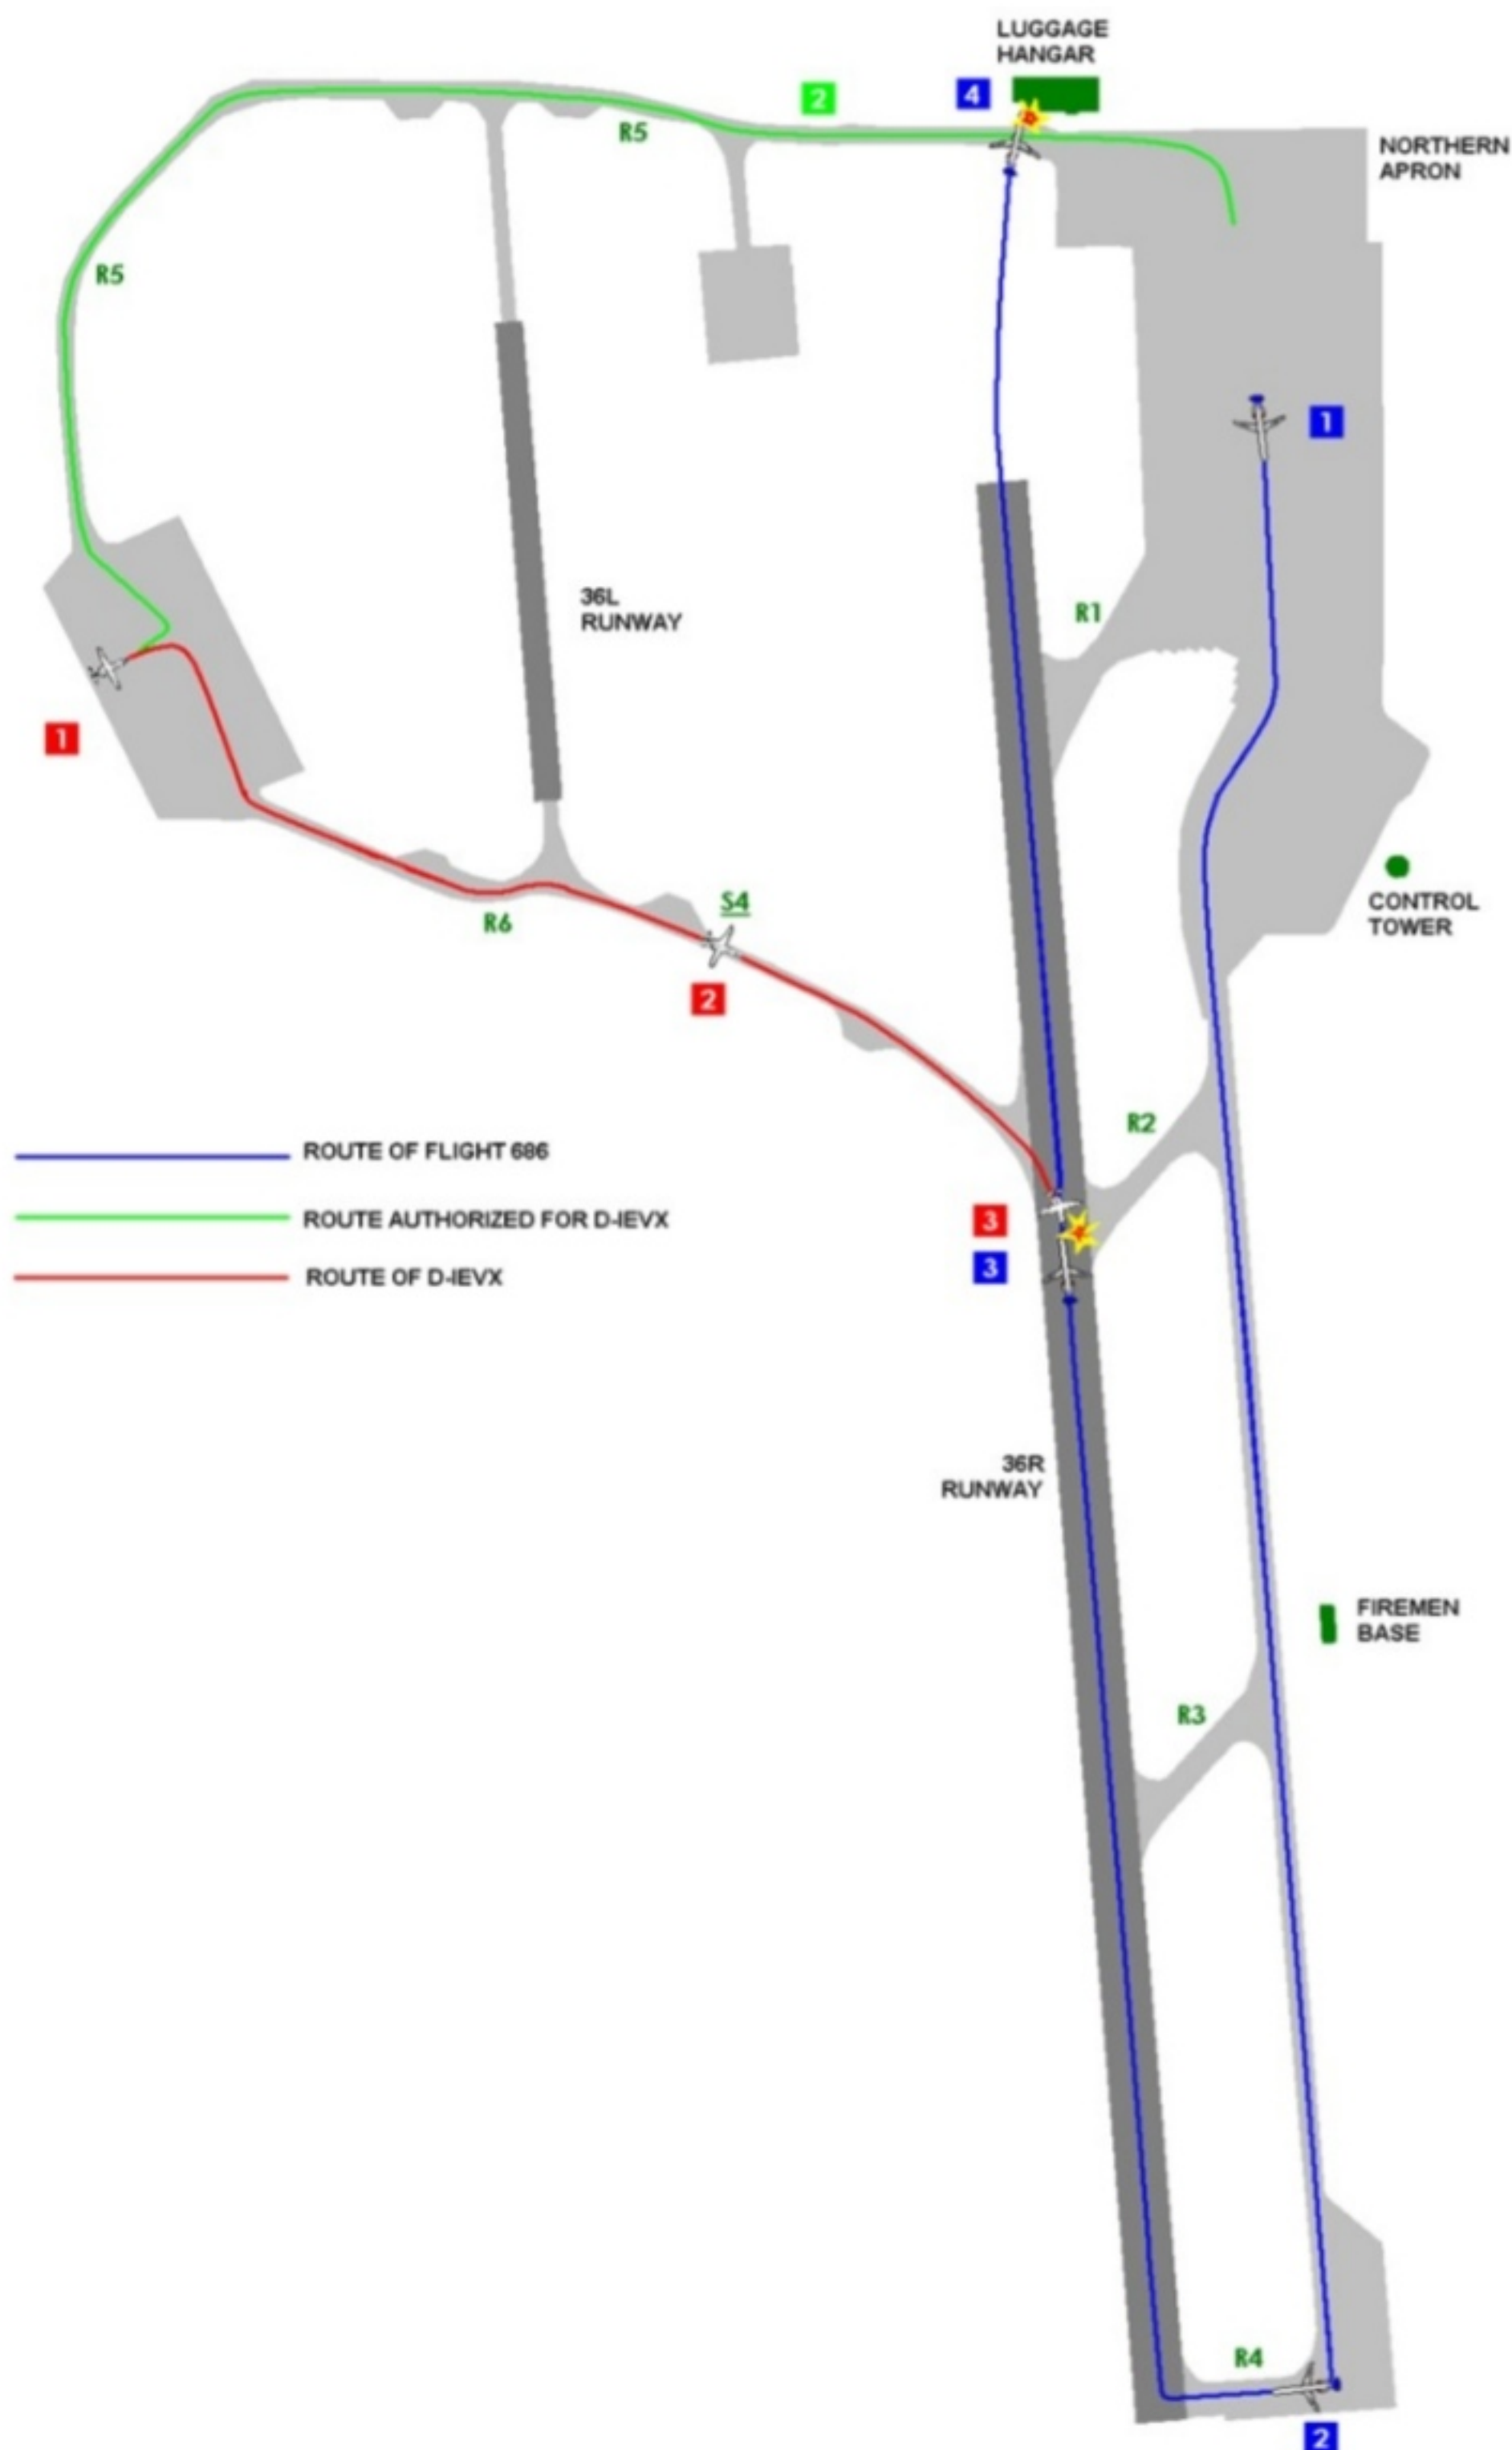
On the 8th of October 2001, at 06.10 UTC, a Boeing MD-87, registration marks SE-DMA operated by SAS, while on take-off run on runway 36R of Milano Linate airport, collided with a Cessna 525-A, registration marks D-IEVX which taxied into the active runway. After the collision the MD-87 continued travelling down the runway, the aircraft was airborne for a short while, and came to a stop impacting a baggage handling building. The Cessna 525-A, which was coming from West apron (General Aviation), remained on the runway and was destroyed by post-impact fire.

Picture 1. Explanation of the accident

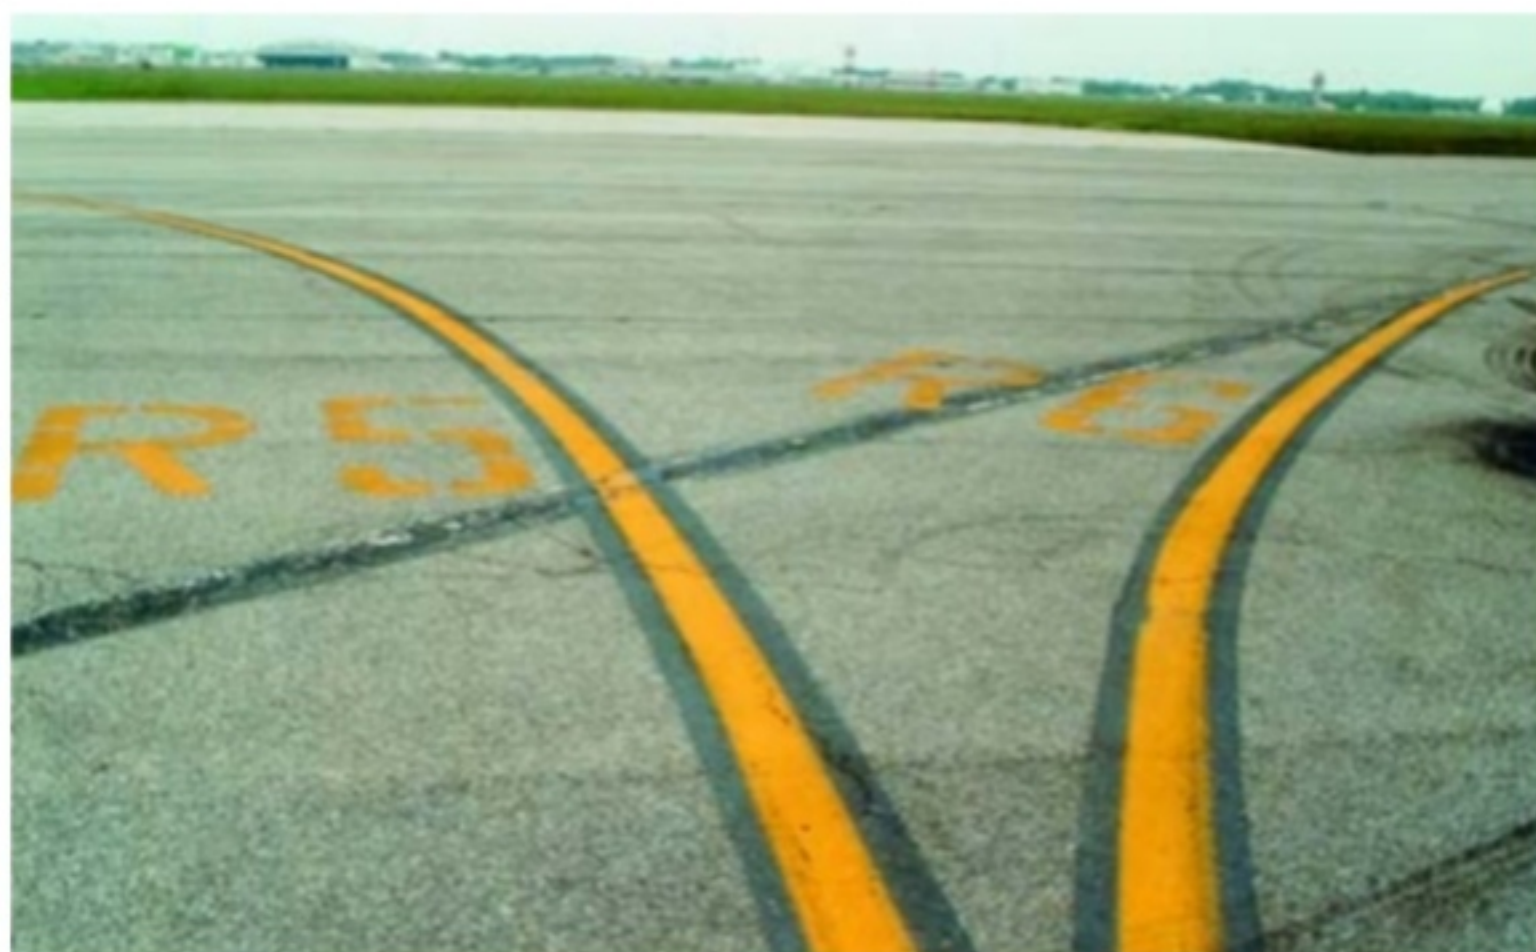
- the Cessna crew was not aided properly with correct publications (AIP Italy – Jeppesen), lights (red bar lights and taxiway lights), markings (in deformity with standard format and unpublished, S4) and signs (non-existing, TWY R6) to enhance their situational awareness;

- the aerodrome standard did not comply with ICAO Annex 14; required markings, lights and signs did either not exist (TWY R6) or were in dismal order and were hard to recognize especially under low visibility conditions (R5-R6), other markings were unknown to operators (S4);
- no functional Safety Management System was in operation;
- the competence maintenance and requirements for recent experience for ATC personnel did not fully comply with ICAO Annex I;
- the LVO implementation by ENAV (DOP 2/97) did not conform with the requirements provided in the corresponding and referenced ICAO DOC 4976.

Picture 2. Markings R5 and R6, the Cessna took R6 while instructed for R5

- Check of state of the airport Visual Aids for all domestic airports, as well as complete information to operate safely to be included in the AIP
- Works on the European Action Plan for Prevention of Runway Incursions
